The vulnerability of solar panels to hail

The vulnerability of solar panels to hail.

Climate-KIC project: *'1 million near-zero energy homes in 2023'*

Teule, T.S., Appeldoorn, M., Bosma, P., Sprenger D.D., Koks, E. & De Moel, H.

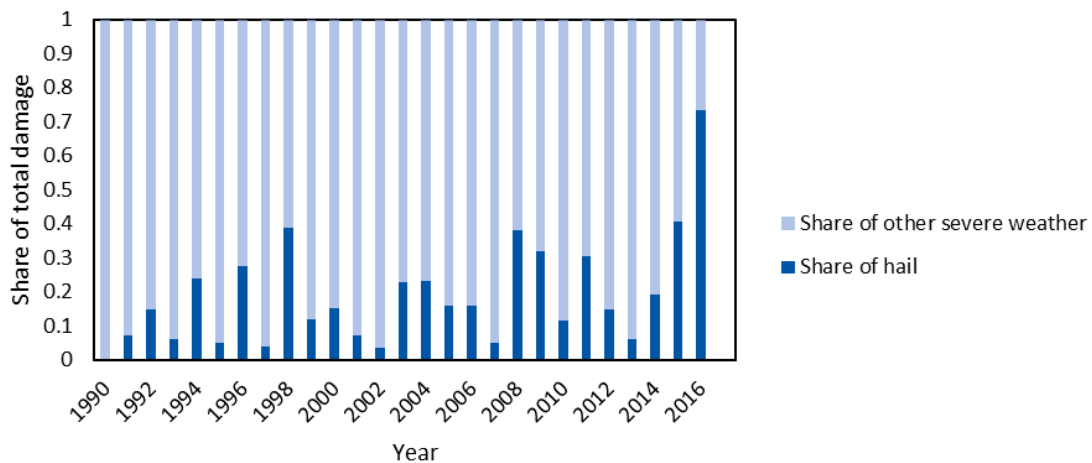
Figure 4: Average share of insured damage due to hail from all insured damage by severe weather per year from 1990 to 2016 (data from Achmea data (2019)).

The Netherlands is one of the countries in Europe that deals with damage due to hailstorms as well. Figure 4 shows an overview of the share of insured damage in the Netherlands due to hail from the total insured damage caused by severe weather (Achmea data, 2019). It can be seen that there are several years that the damage due to hail plays a large role in the total damage. For example, in 2016, 73% of all insured damage caused by extreme weather is caused by hail, but on average it makes up 19% of the total damage by severe weather. However, it must be kept in mind that the data before 2007 does not include all the damage data from the insurance company. So, the graph gives an overview of the share of hail damage, also before 2007, but it does not give the exact shares of damage.

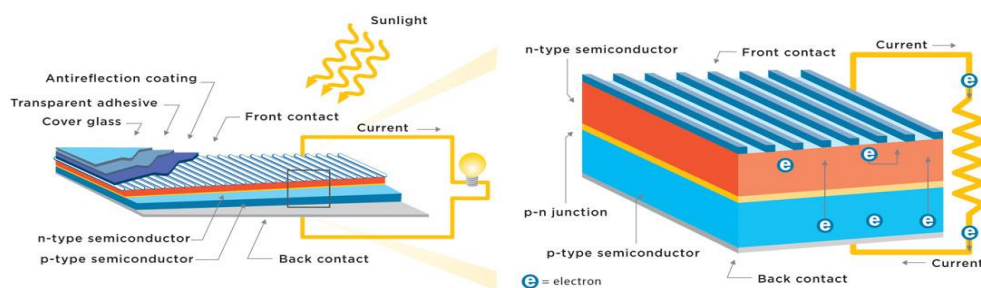
Figure 7: Fundamentals of a solar panel and solar cell (Alpine Solar, 2019).

Solar panels are boards of solar cells. The solar cells use light energy to generate electrical energy. The mechanism behind this conversion is called photovoltaic energy conversion (Soga, 2006). While the materials used in solar cells differ, the structure of solar cells remains the same (Fonash, Ashok, & Fonash, 2018). The structure of a solar panel and cell can be seen in Figure 8 (Fonash et al., 2018).

Sunlight first encounters the antireflection layer. This layer has an optical coating, which is made to minimise the loss of light and retain the light as best as possible. In order to do this, the transmission of the light to subsequent layers is promoted. Those subsequent layers convert energy. They consist of a top-junction layer, an absorber layer, and a back-junction layer. These three layers, together with the antireflection layer, are situated between two electrical contact layers. The front electrical contact layer consists of very thin and widely spaced grid lines. Those grid lines are made to be as small as possible, in order to minimise the blockage of light. The back electrical contact layer does not have any restrictions on its surface area and therefore covers the entire back of the solar cell (Fonash et al., 2018).

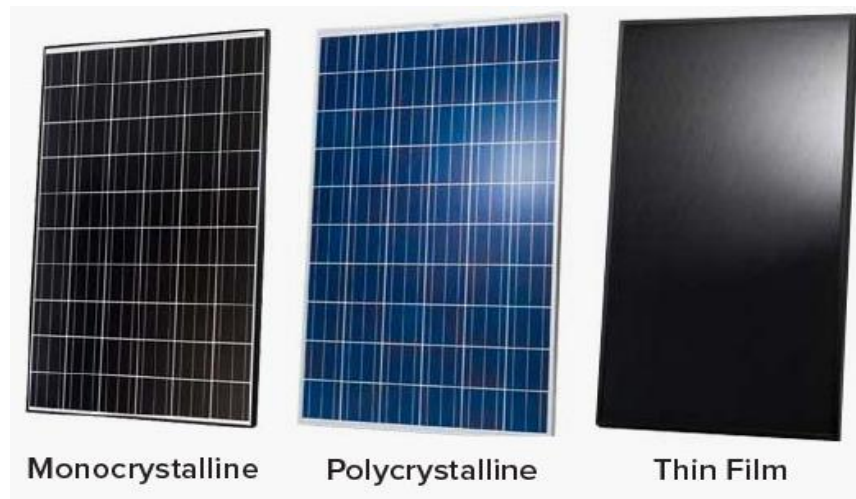
Figure 8: Three different types of solar panels (Solarmarket.com.au, 2019).

Solar panels can be divided into a few categories: monocrystalline solar panels, polycrystalline solar panels, and thin-film solar panels. The first two are silicon-based solar cells (Hussain, 2018). They are named after the material of the semiconductor and currently hold the largest market share in the Netherlands (Consumentenbond, 2019b). Monocrystalline solar panels are currently the most efficient type of solar panels (Consumentenbond, 2019b). Polycrystalline solar panels are less efficient than monocrystalline solar panels but are also less expensive. Monocrystalline panels can also be made into all-black solar panels. Those panels are aesthetically well designed and have an all-black appearance. However, all-black panels absorb more heat on the parts around the antireflection layer, which lowers the efficiency of the panel.

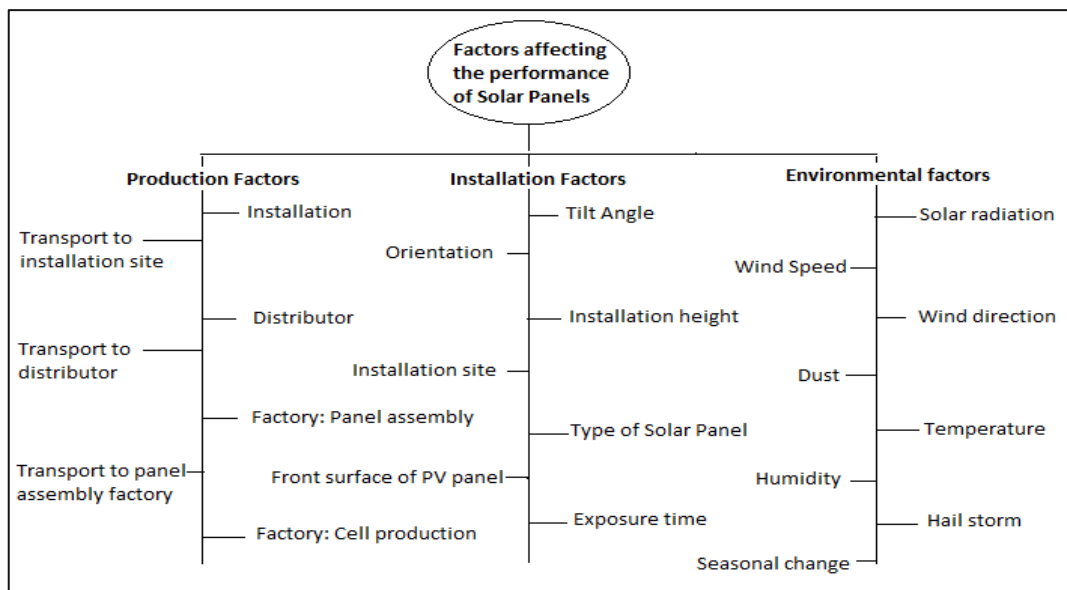
Figure 9: Factors affecting performance of solar panels, adapted from the research of Gupta et al. (2019)

As proposed by Gupta et al. (2019) the current factors that are expected to affect the performance of solar panels are divided into two categories, environmental factors, and installation factors. In this study, all interviewed stakeholders stated that currently the supply chain from producing the cells until the installation is poorly regulated (Achmea, 2019a; Achmea, 2019b; SolarClarity, 2019). This is leading to damages that can occur somewhere in the supply chain, leading to the third category of damage factors, the production factors. Figure 10 shows these three categories with the corresponding factors. This shows that many factors can damage the solar panels which are not only happening due to environmental factors like hail but can already happen during the production and installation process.

Figure 10 shows an overview of these three categories. During the production solar panels can get damaged during transport, installation or already at the factory. Installation factors can affect the performance of the panels as well, by the choice in type of solar panel, the orientation, and the tilt angle of the panel for example. Environmental factors can affect the performance after the panel is installed due to wind, dust, and hail for example.

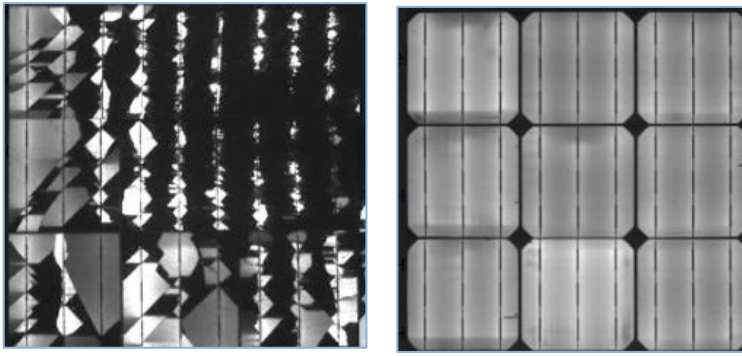
Figure 10: Results of electroluminescence of (a) visible and (b) invisible (micro-cracks) damage to a solar panel (provided by Solar Tester Nederland (2019)).

The above factors can potentially cause damage to the solar panels which can occur in different forms. The front glass surface of a solar panel can crack after the impact of an object. This type of crack is directly visible. The crack reduces the solar insolation to enter straight to the solar cell which consequently results in a lower yield (Gupta et al., 2019). Smaller cracks that are not formed in the front glass layer but in the more fragile silicon layer are called micro-cracks (Solar Tester, 2019). These micro-cracks can only be seen using special tests, an Electro Luminescence test for example. In this test, the light output increases with the voltage so areas with cracks appear as dark spots. Therefore, the test can show the shape of the cracks and can indicate the cause of the crack. For example, a star-shaped micro-crack can indicate the impact of a small object, like a hailstone. Micro-cracks usually do not show a lower yield initially, but will after a few months (Solar Tester, 2019). In Figure 11 a simple example of visible and invisible damage is given. Other methods that can inspect the damage to installed solar panel modules in the field are thermography technique and the UV-fluorescence imaging method. The thermography technique is most commonly used in the field, using a portable camera that can detect thermal hot spots indicating disconnection between modules or strings for example (Gupta et al., 2019).

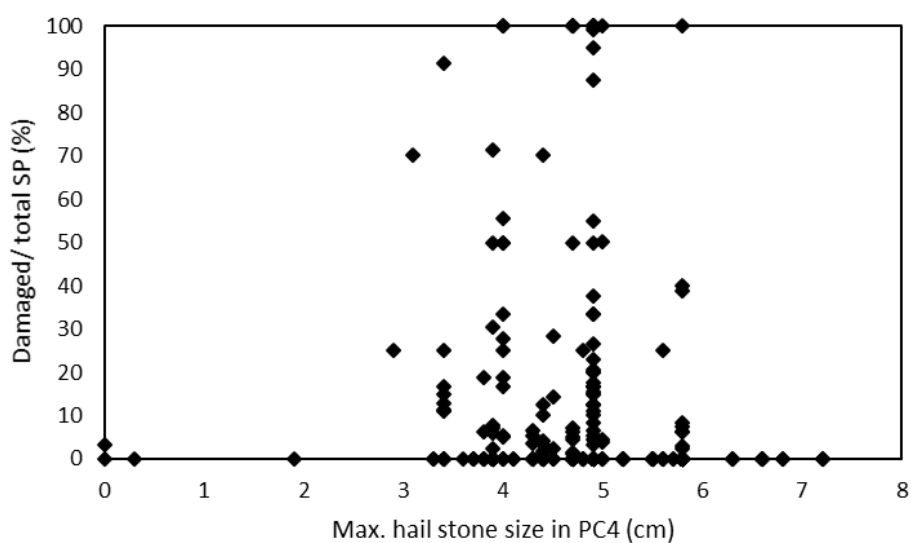
Figure 14: Share of damaged solar panels of the total number of solar panels per claim in relation to the max. hail size (cm) (based on data from Achmea (2019) and KNMI (2019)).

Figure 15 shows the share of damaged solar panels from the total number of solar panels on a building, in relation to the maximum hailstone size in the postcode where the claim was located. Most damage to solar panels starts from a maximum hail size of 3 cm or more. It can also be seen that there are two claims where the detected hail size by the radar was 0 cm, but there was some damage, this is probably related to uncertainties in the hail stone size estimation (i.e. the radar imagery augmented numerical weather model data). Larger maximum hail sizes than 3 cm, are causing more damage. The hail can cause only a few percent of the solar panels to be damaged or can lead to all the panels on a roof to be damaged. There are not many claims in postal code areas with hail with a maximum size of 6 cm or larger, so the low damage percentage factors should not be considered indicative for the overall vulnerability.

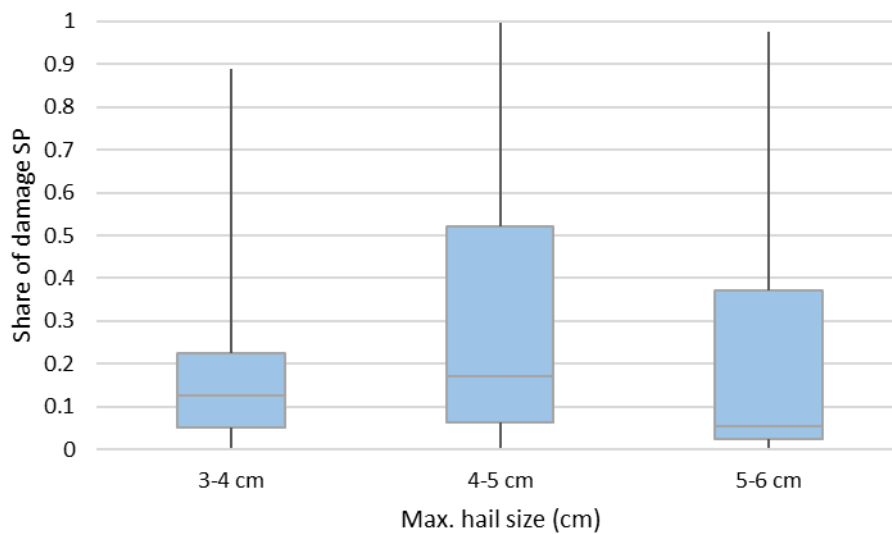
Figure 15: Share of damaged SP per claim in relation to max. hail size (cm) for 3-4 cm and 5-6+ cm

Figure 16 presents three boxplots for claims with damage with a maximum hail size of 3-4 cm, 4-5 cm and 5-6 cm. The lower hailstone sizes are not taken into account as these were only two claims. Hailstones of 4-5 cm cause on average more damage than hailstones of 3-4 cm, but also show a wider range of damage. The hypothesis is tested that solar panels that were hit by hailstones of 4-5 cm have more damage than solar panels that were hit with hailstones of 3-4 cm. The results of a t-test (one-tailed) showed that this was indeed the case ($p\text{-value} = 0.063$, one-tail). However, the figure also shows that hailstones of 5-6 cm show a lower average damage. This might be due to more variety in hailstones in an area with high maximum hailstone sizes. The chance that a solar panel was actually hit by such a large hailstone is not very high. A t-test shows there is no significant difference between these two groups ($p\text{-value} = 0.250$, one-tail).
